Insured: Sample Interior
Location: 5575 Shady Ave
 Lowville, NY 13367
Control #: 230177

Customer: GG test customer
Policy Number: jgyjhgguhkjlh
Agent: Test Agent Name

SURVEY CONDITIONS

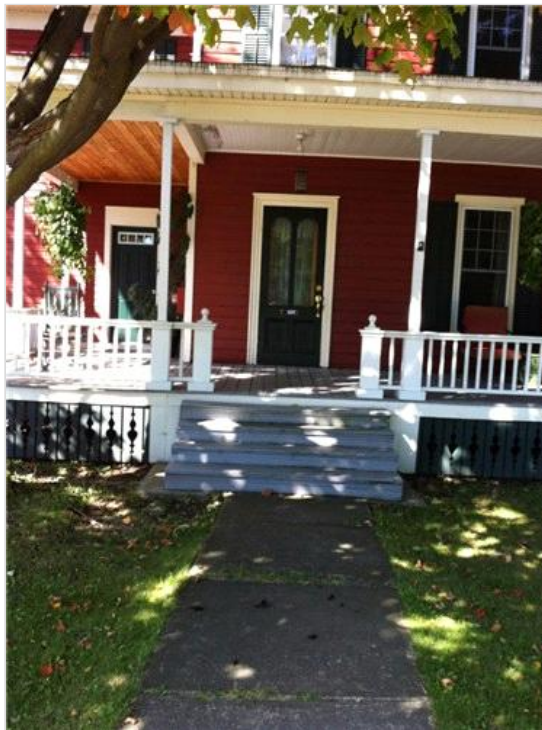
REC missing railing at front steps

2012.5. The steps at the front, back and side of the dwelling should be provided with handrails. Handrails should be provided on all steps with three or more risers. The height of handrails is to be from 34" to 38" high, measured from the nose of the tread. If stairs are more than 44" wide, handrails are to be provided on each side. If stairs are 88" wide or more, install the handrails on both sides, with intermediate handrails in the center.

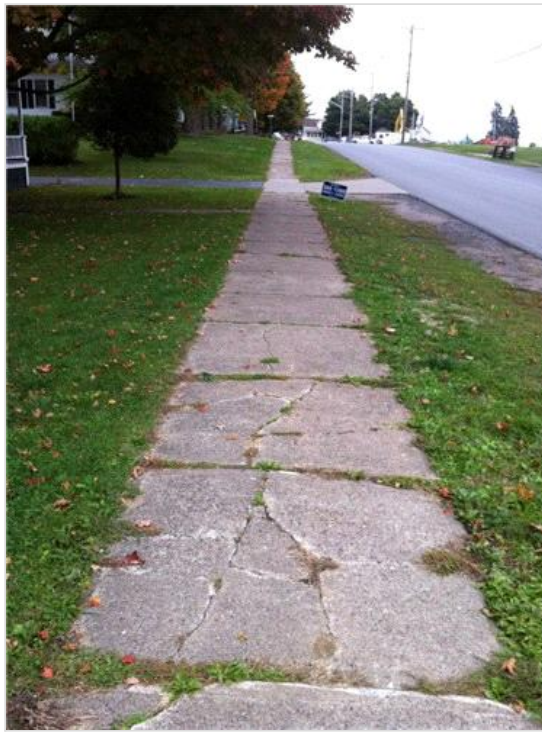
REC uneven sidewalk

2012.6. The sidewalk should be repaired to present a smooth and even walking surface and reduce the tripping hazard.

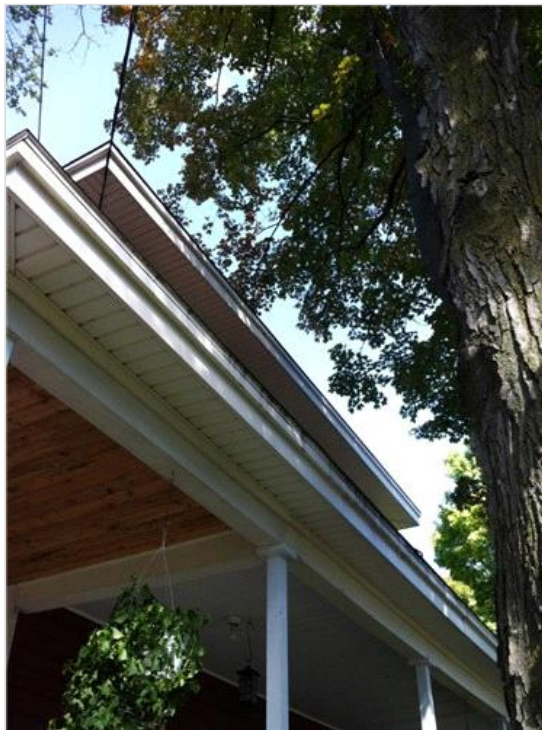
REC trees overhanging front of dwelling

2012.3. Overgrown trees at the front of the dwelling should be trimmed away from the building to reduce the physical damage exposure.

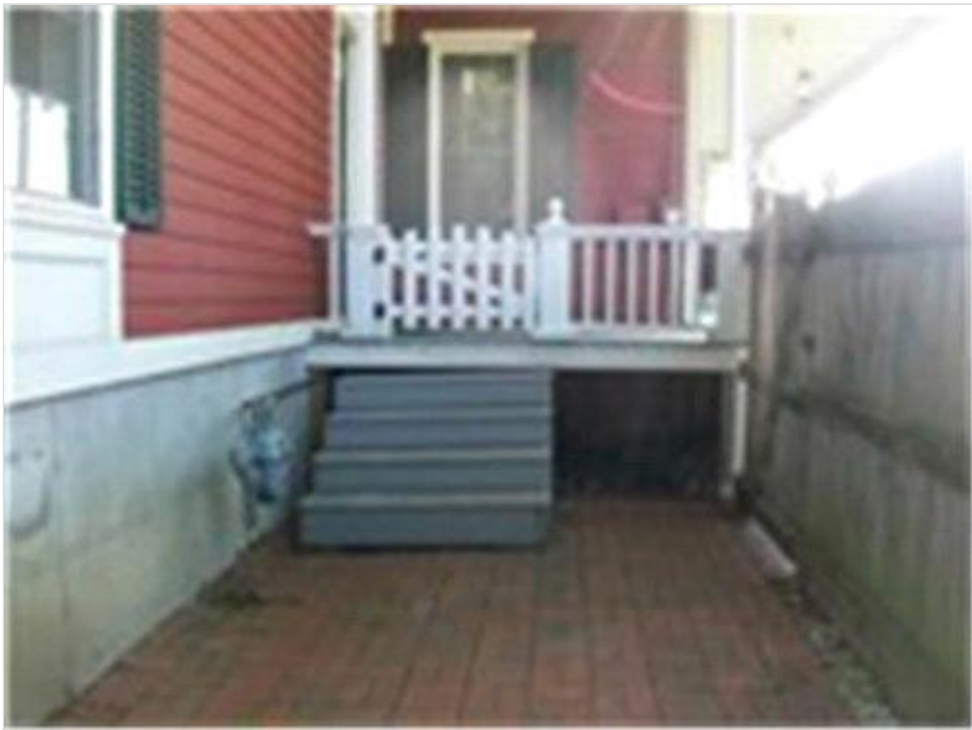
REC uneven steps and missing railing at side steps

2012.7. The steps to the side open porch are uneven and should be leveled to reduce the slip/fall exposure.

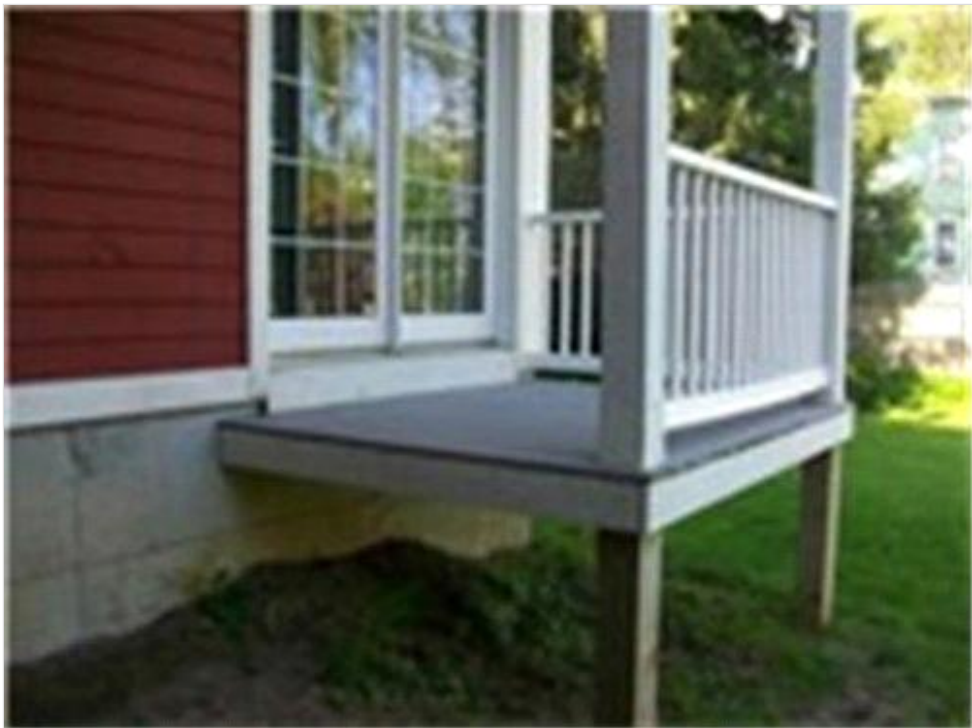
REC missing steps

2012.4. The lower level of the 2 story open porch on the back of the dwelling should have steps installed. Handrails should be provided on all steps with three or more risers. The height of handrails is to be from 34" to 38" high, measured from the nose of the tread. If stairs are more than 44" wide, handrails are to be provided on each side. If stairs are 88" wide or more, install the handrails on both sides, with intermediate handrails in the center.

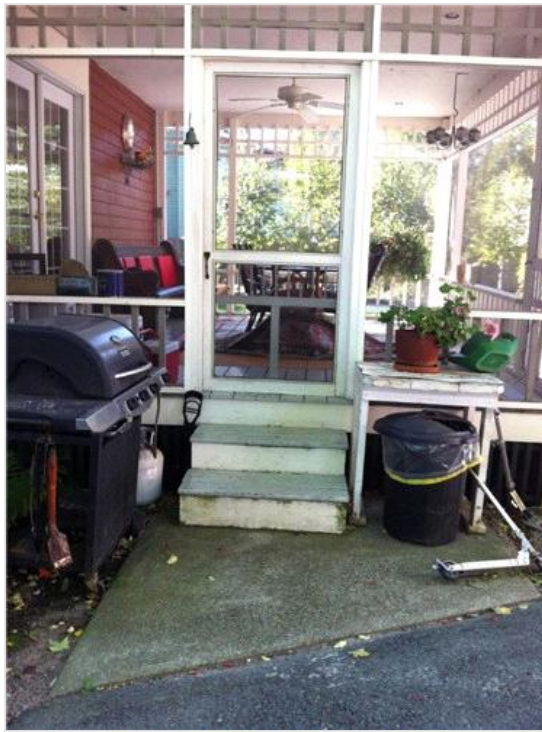
REC railing missing at back entrance

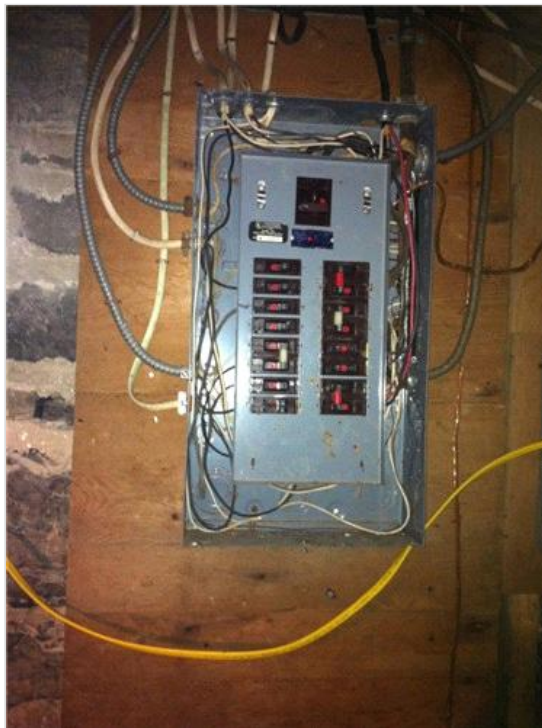
REC missing cover and loose wire should be restapled

2012.9. The panel box in the dwelling basement was noted to have a missing cover. The missing cover should be replaced to reduce the electrical hazard.

2012.10. The wiring at the panel box in the basement area should be re-stapled so that it is properly supported. This will minimize the potential for breaks, cracking and insulation wear.

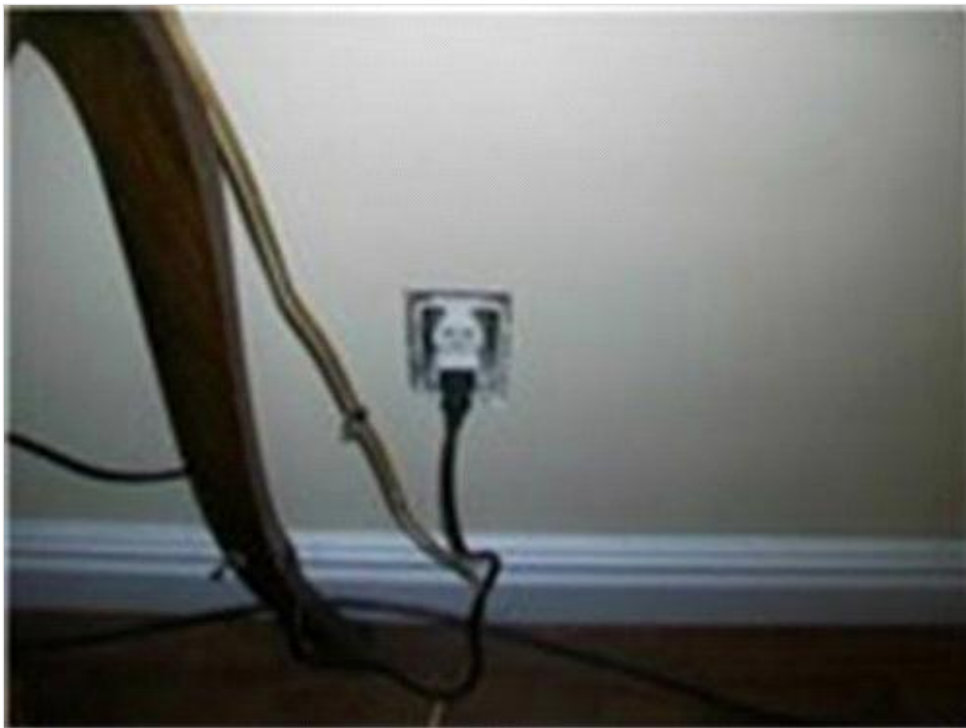
REC missing outlet cover in diningroom

2012.11. The outlet box in the diningroom was noted to be missing a cover. The missing cover should be replaced to reduce the electrical hazard.

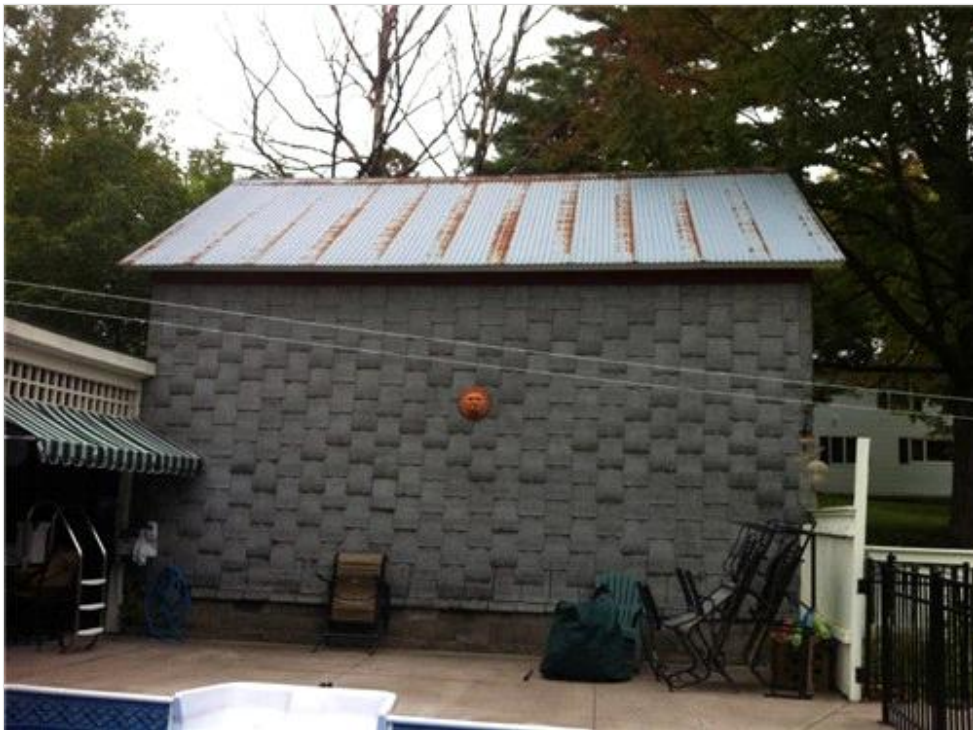
REC rusted roof on garage

2012.2. The metal roof of the garage is rusted and should be recoated to reduce the water and physical damage exposure.

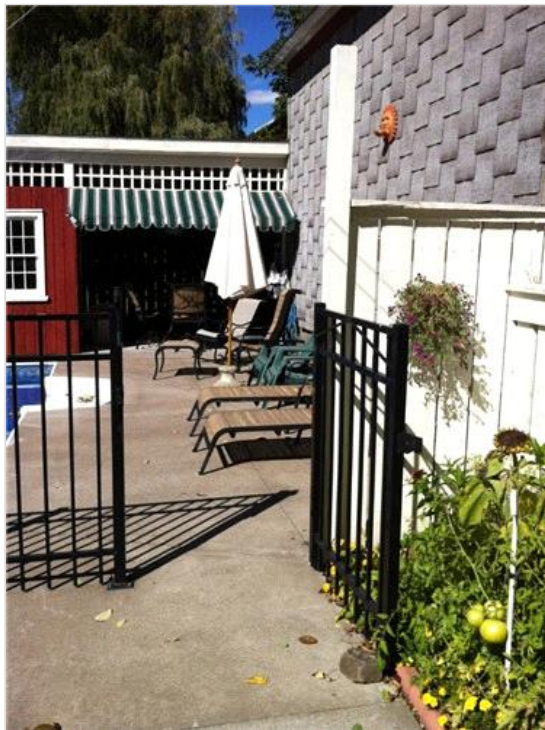
REC gate to pool open

2012.8. All pool gates should have self closing latches and be securely locked with a key, combination or other child proof lock sufficient to prevent access to the swimming pool through such gate when the swimming pool is not in use or supervised

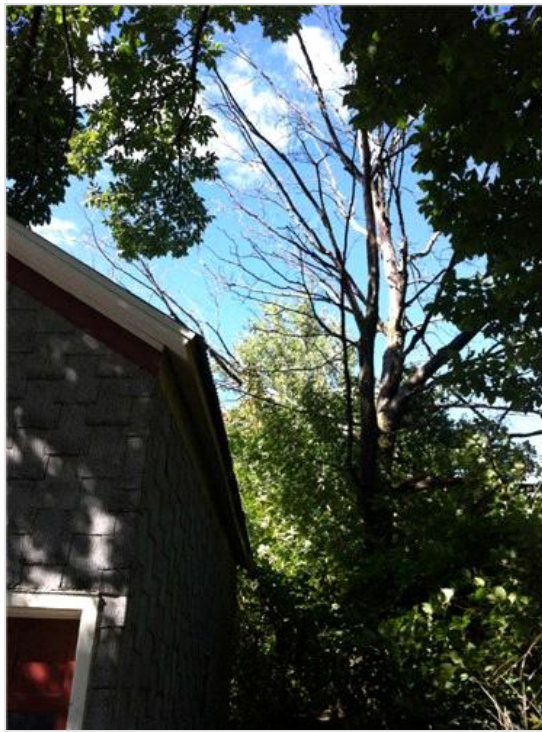
REC dead tree overhanging garage

2012.1. Overgrown dead tree should be removed from the garage area to reduce the physical damage exposure.
