Insured: Sample Interior
Location: 5575 Shady Ave
 Lowville, NY 13367
Control #: 230177

Customer: GG test customer
Policy Number: jgyjhgguhkjlh
Agent: Test Agent Name

SURVEY CONDITIONS

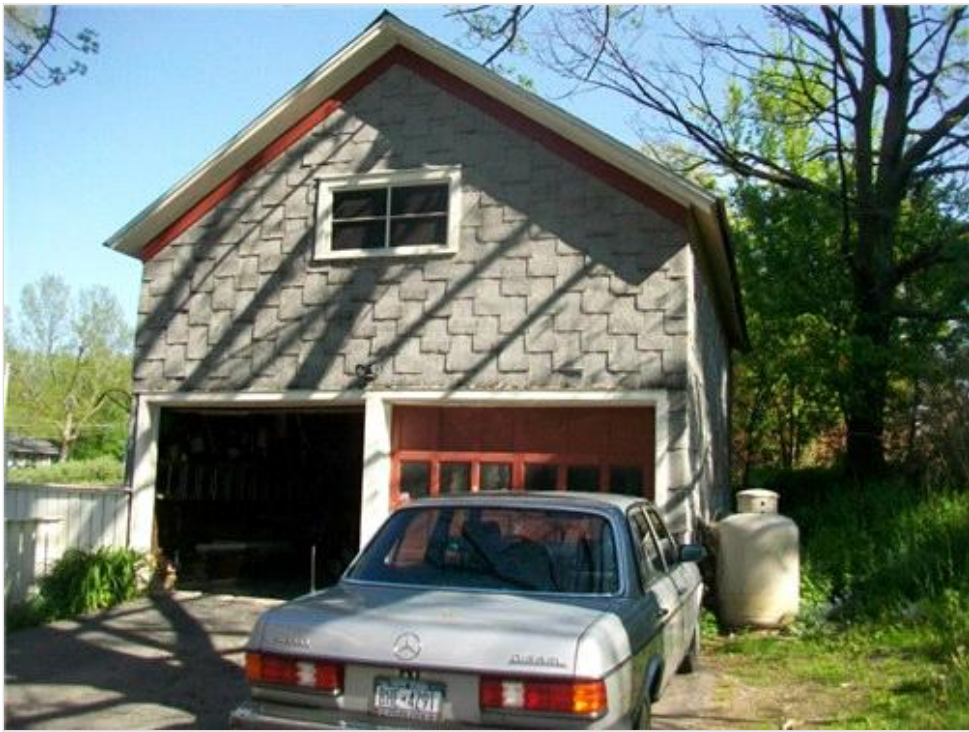
Outbuilding #1	Defects
Outbuilding defects observed	Other
Other outbuilding 1 defect was	deteriorated tree overhanging garage
Description and Comments	There is a dead tree overhanging the garage and the metal roof is rusted
Outbuilding #2	None
OUTBUILDING Comments	There is a detached garage and in-ground pool in the back yard.

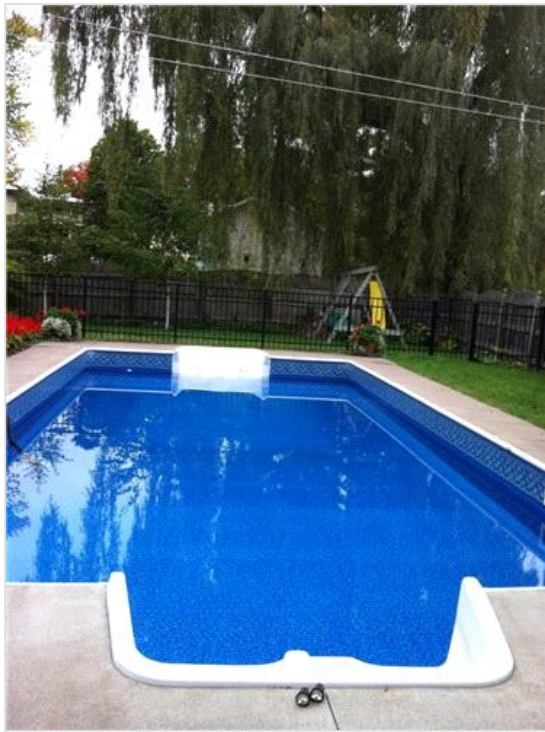
Pool, Hot Tub or Spa on premise	Yes	 
Pool type	In ground	
Pool alarm installed	No	
Diving Board	No	
Pool Fenced	Yes	
Pool fence protects entry from dwelling	Yes	
Pool fence protects entry from neighbors	Yes	
Pool Gate Secured	No	 
Additional defects observed	None
